# SAFETY ALERT

## Lightning strikes stationary truck

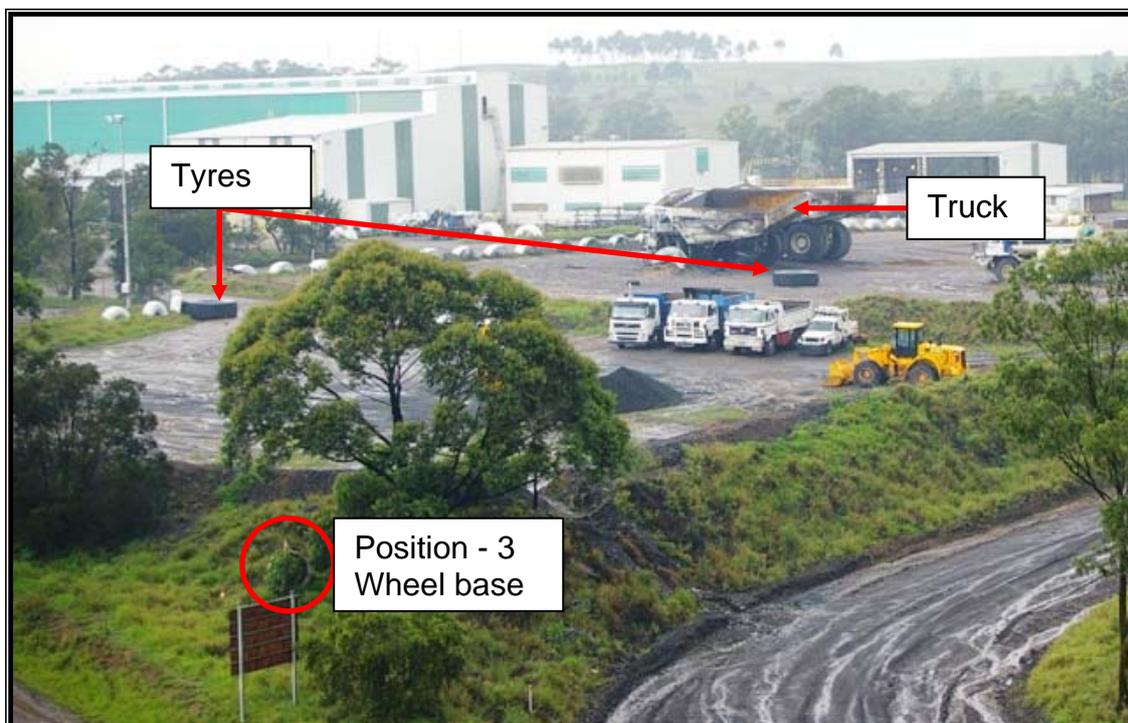
Figure 1: Parking area

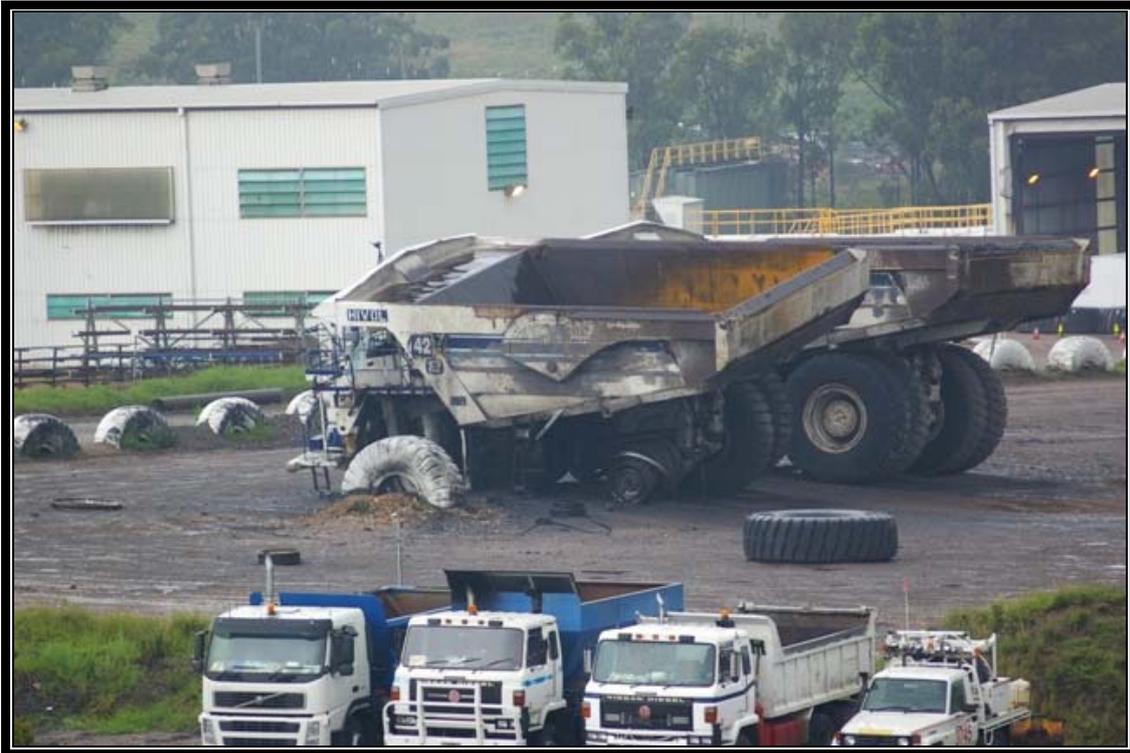
1. The truck operator's rear cabin window was blown into the cabin and all other windows were blown outwards from the cabin. The driver's door was blown open.

2. The final drive was extensively damaged. The rear outer position 3 wheel base exploded off the final drive breaking 57 one-inch grade 10.9 bolts in tension with a calculated force of approximately 270 kNewtons. The final drive outer planetary carrier and axle were blown off the truck.

Figure 2: Close-up of the truck

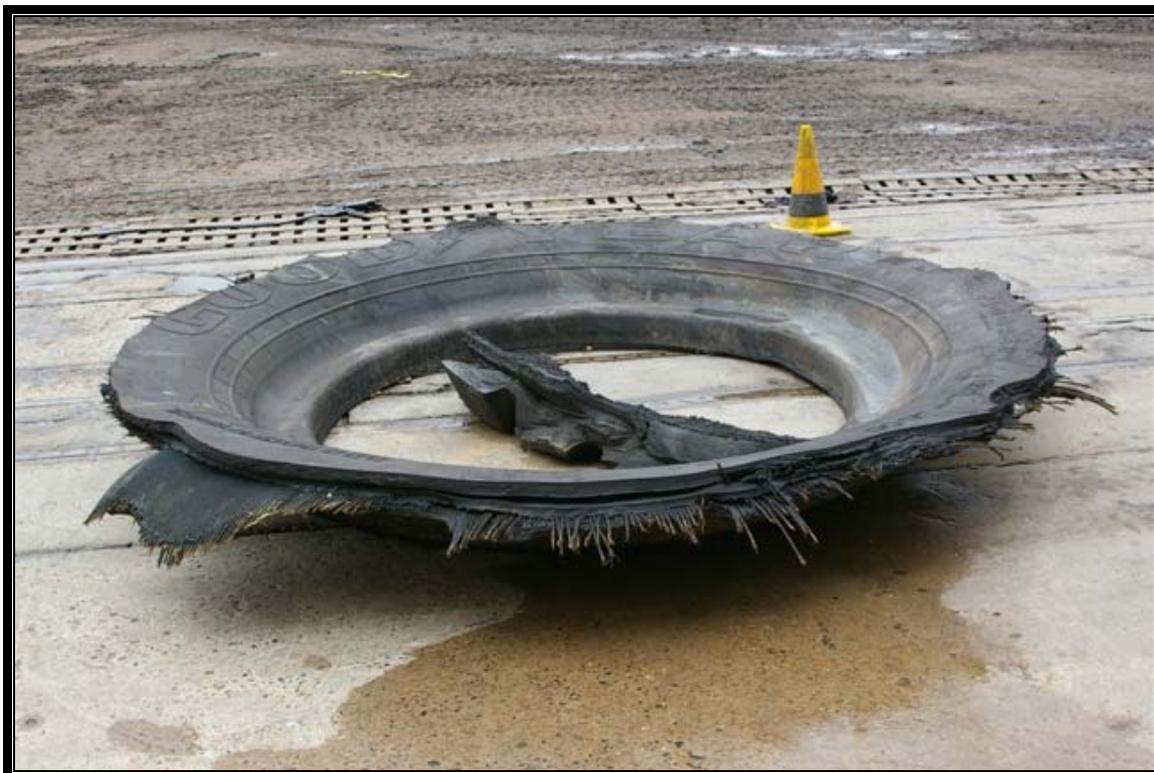
3. Position 1 tyre (new tyre) had one complete side wall blown out.
4. Position 3 tyre had the side wall blown out for three-quarters of the circumference.

Position 1 tyre (driver's side front) showed evidence of earthing through this tyre, and it's believed the lightning earthed through No 1 and No 3 position tyres.

Figure 3: Tyre side wall from position number 1
